# Manhole Inspection Summary

Manhole # S29I\_\_016MH

Insp Date: **9/10/08 9:17 AM**

**Location** Address: **122 Penn St**

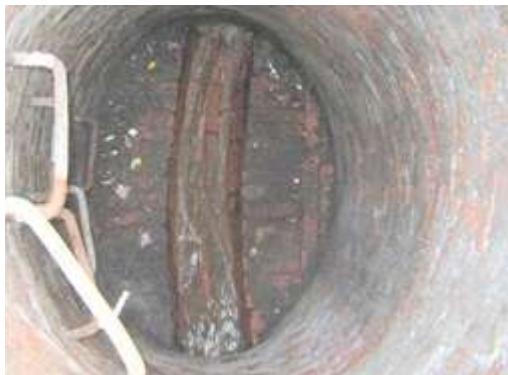
Top View

Debris on bench

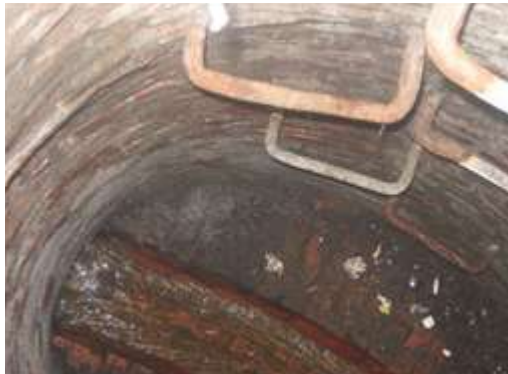
Defect 2

**Steps** Count: **5** Missing: **0** ☒ Corroded

Corroded steps

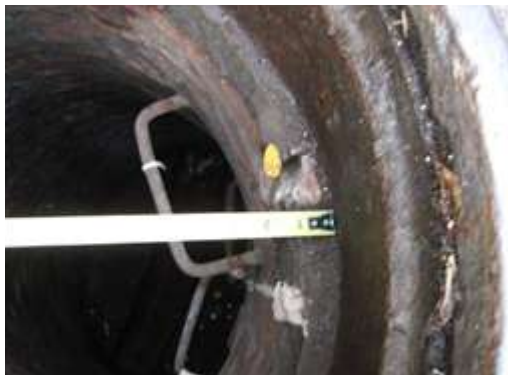
### Defect 1

**Frame** Offset: **1.5** (in.) Condition: ☒ Sound ☐ Cracked ☐ Leaks

2" Offset

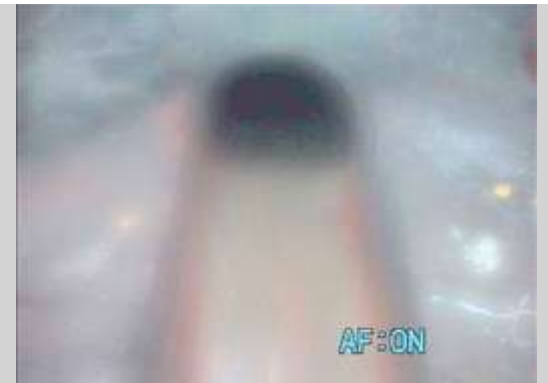
5 O'Clock Inflow

10 in. Circular Gravity Sewer  
Pipe In @ 5 O'Clock

Pipe Height: **10.8** (in.) Rod and Bar (Angled)  
Pipe Material: **Clay** ☐ Pipe Lined  
Invert Depth: **9.47** (ft.) Flow Characteristics: **Fast**  
Deposits: ☒ None ☐ Mud ☐ Sludge ☐ Debris ☐ Grease  
Silt Depth: **0** (in.) Deposits Extent:  
Infiltration: **None** Pipe Seal Cond: **Sound**
